# SUGGESTED PRACTICES FOR RAPTOR PROTECTION ON POWER LINES

## THE STATE OF THE ART IN 1981

Raptor Research Report No. 4  
Raptor Research Foundation, Inc.  
1981

Richard R. Olendorff  
Endangered Species Coordinator  
California State Office  
U.S. Bureau of Land Management  
2800 Cottage Way  
Sacramento, CA 95825

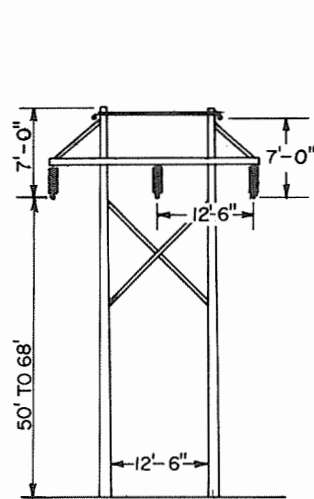
TYPICAL 115KV WOOD H-FRAME

(SUFFICIENT CONDUCTOR SPACING PREVENTS  
PHASE-TO-PHASE OR PHASE-TO-GROUND CONTACT.)

Most lines that electrocute raptors are distribution lines (Figure 2) that carry between 12,000 and 69,000 volts. Higher voltage transmission lines (Figure 1) pose little electrocution hazard because wire separation is adequate.

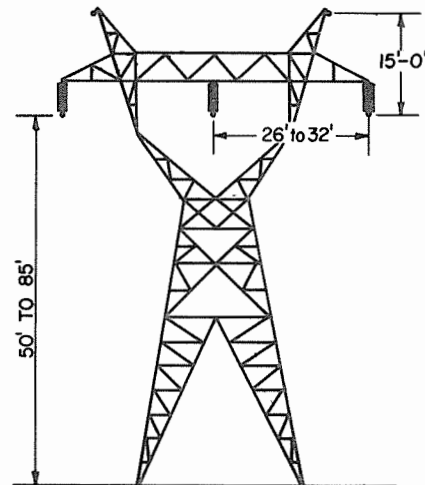
TYPICAL 345/500KV  
TOWER CONFIGURATION

transmission lines will have two overhead ground wires for lightning protection in addition to the three phases of electrical conductors. Each transmission circuit utilizes three separate phases to transmit electrical energy.

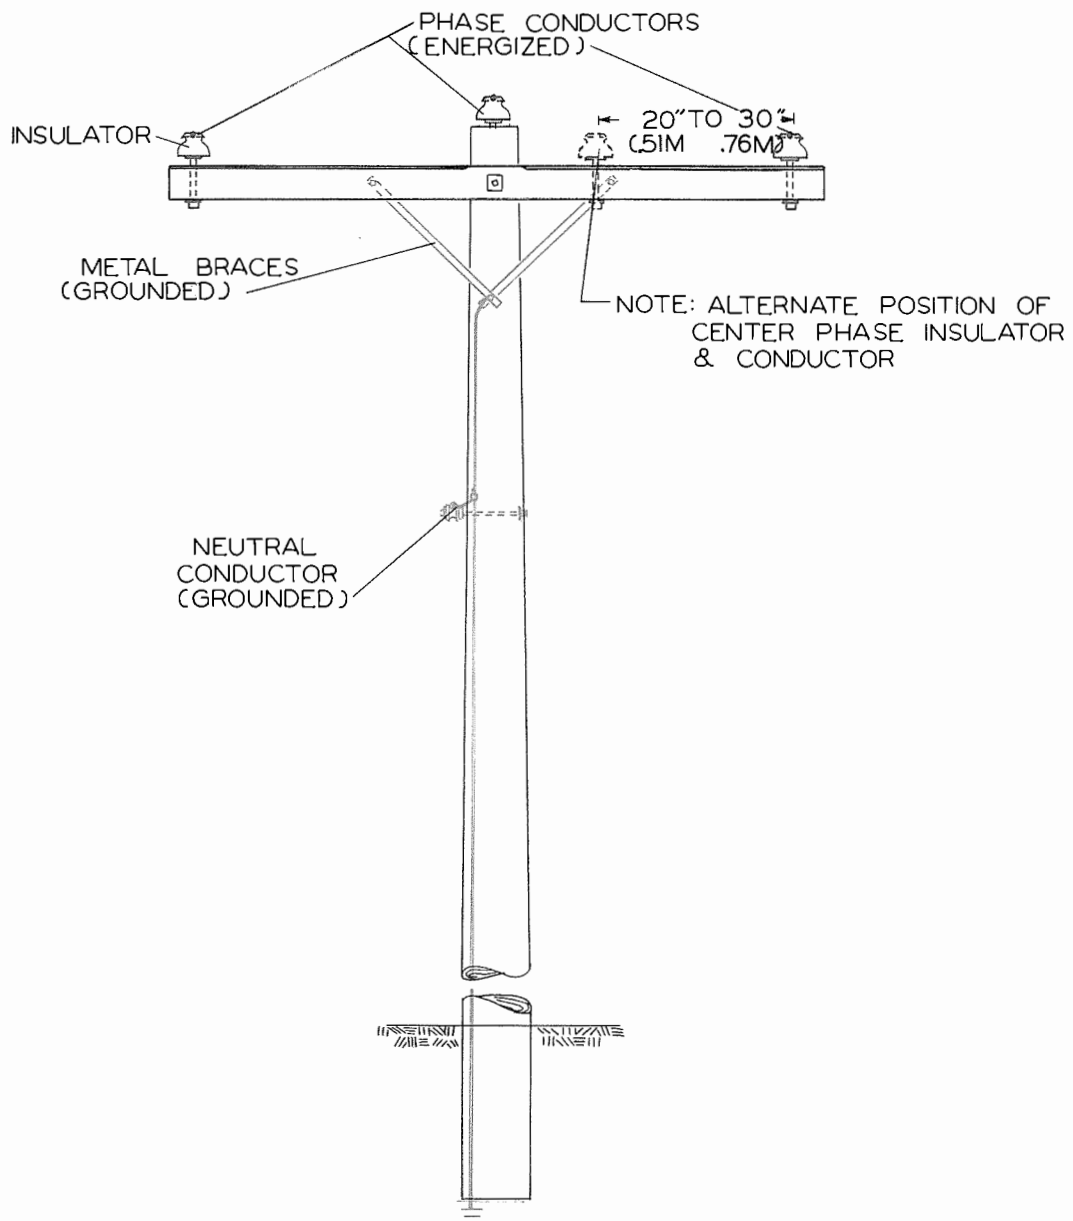
FIGURE 4  
THREE-PHASE PROBLEM DESIGN

The second extremely hazardous design is three-phase, single pole construction where a 6- or 8-foot (1.8- or 2.4-m) crossarm provides excellent perching opportunities to birds, but conductor spacing is insufficient (about 3 to 4 feet (0.9 to 1.2 m.)) to prevent their electrocution (Figure 4). Grounded steel crossarm braces add to the hazard of this design. Although its specifications were changed in 1962, this design remained very much in evidence in the field during the 1970s. Two variations of this design are common; one has the center phase carried on an insulator atop the pole, and the other has the center phase on an insulator mounted on the crossarm beside the pole top and closer to one of the outside phase wires (Figure 4). In the latter case, conductors are forced closer together, and the hazard increases proportionately.

The two main considerations for making electric power poles safe for eagles are: 1) modifications of existing problem lines (Figures 3 and 4) and 2) proper design of new facilities. Both approaches are still vitally necessary, but because of the vast diversity of line designs and voltages used by different power companies, across-the-board standards and guidelines are impractical. Nonetheless, specific problems can be attacked on a broad front including: 1) design and modification of poles, crossarms, and wire placements to effect adequate separation of energized hardware; 2) insulation of wires and other hardware where sufficient separation cannot be attained; and 3) management of eagle perching.

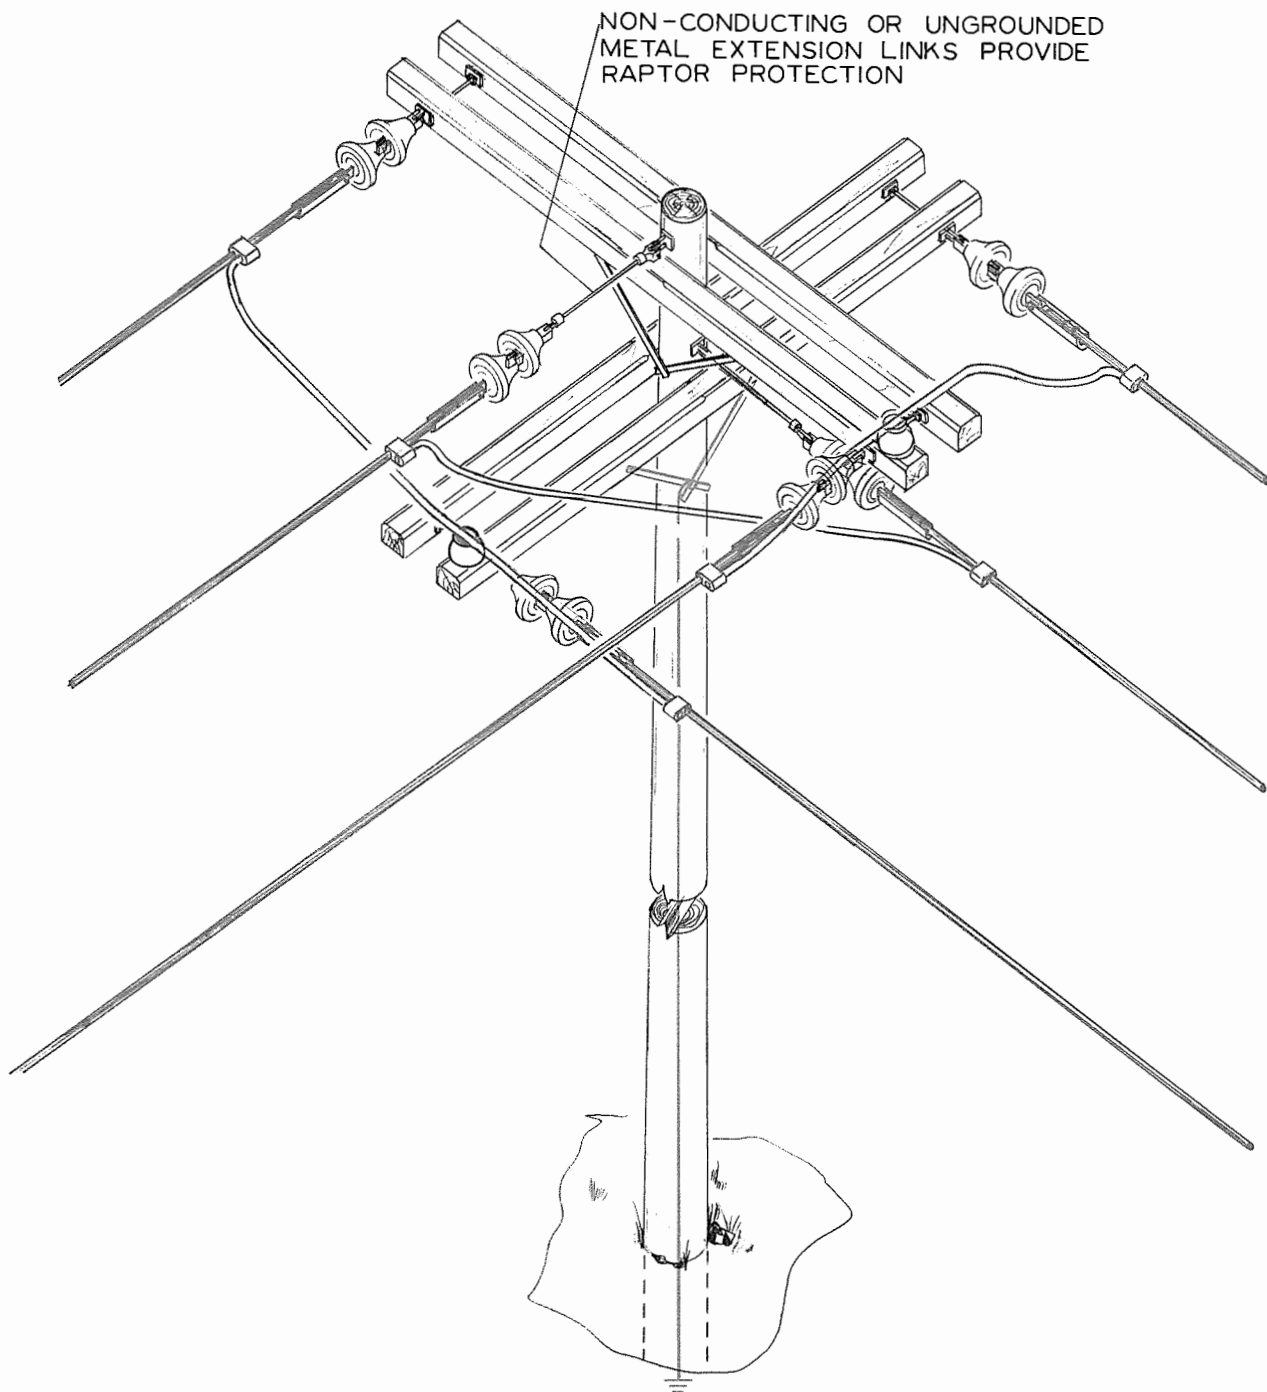
FIGURE 6  
TYPICAL THREE-PHASE CORNER CONFIGURATION

Where primary deadends occur, such as on corner poles, non-conducting extension links can be installed to keep the phase wires further away from the pole and crossarms (Figure 6). By running any necessary jumpers underneath the crossarms, phase-to-phase contacts can be minimized. An eagle can then safely perch on top of the pole or on the crossarm. Metal extension links can be used if they are not grounded.

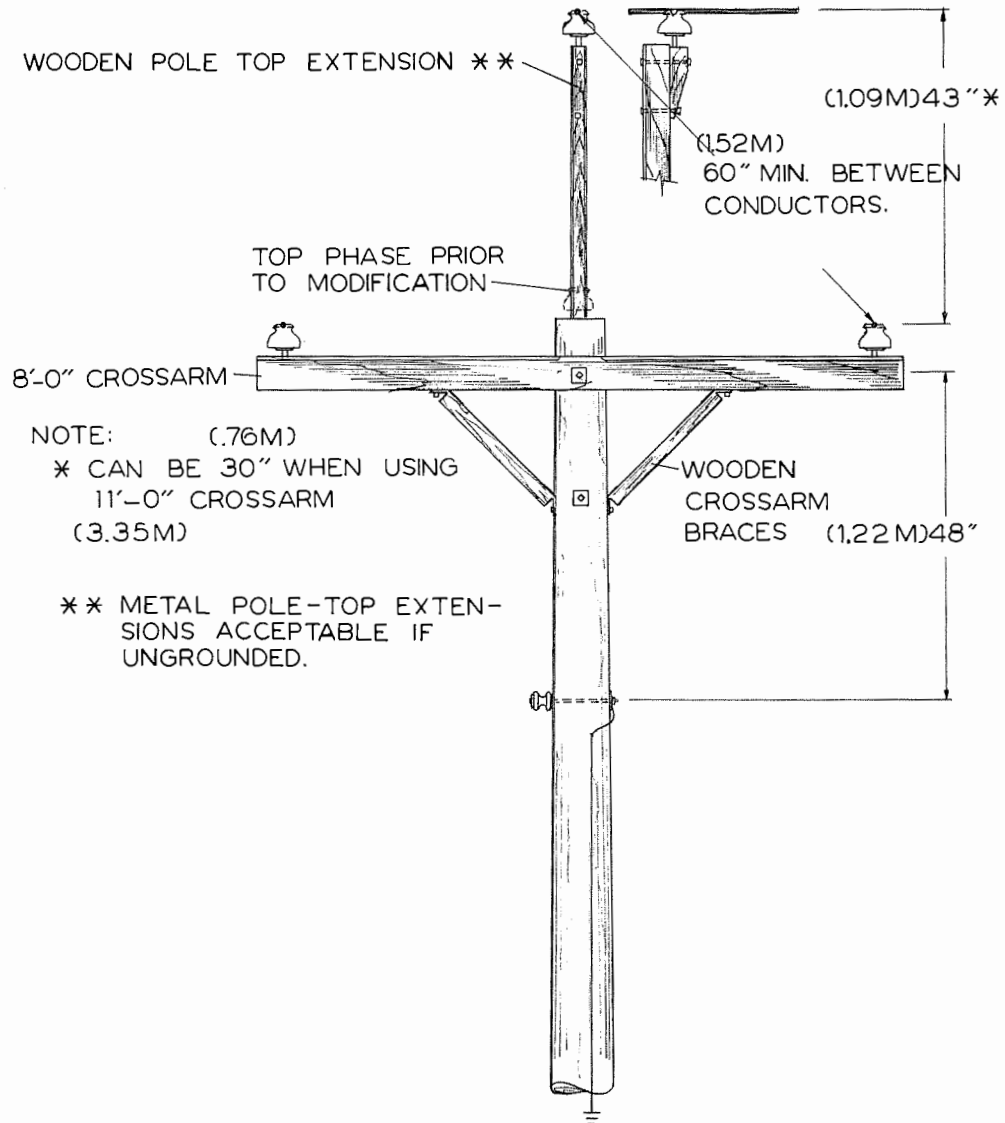
FIGURE 7  
POLE-TOP EXTENSION

A more popular option has been to raise the center conductor further above the outside conductors using a pole-top extension (Figure 7) (Nelson and Nelson 1976, 1977; Benson 1981; Miller et al. 1975). These extensions are costly, yet when a solution is necessary, this may be the least expensive method.

Adequate separation of energized wires, ground wires, and other metal hardware is the most important factor in preventing raptor electrocutions. The objective is a 60-inch (152-cm) minimum separation of conductors. This can be accomplished in retrofitting old three-phase lines by lowering the existing crossarm (Figure 8) or by raising the center wire on a pole-top extension (Figure 7).

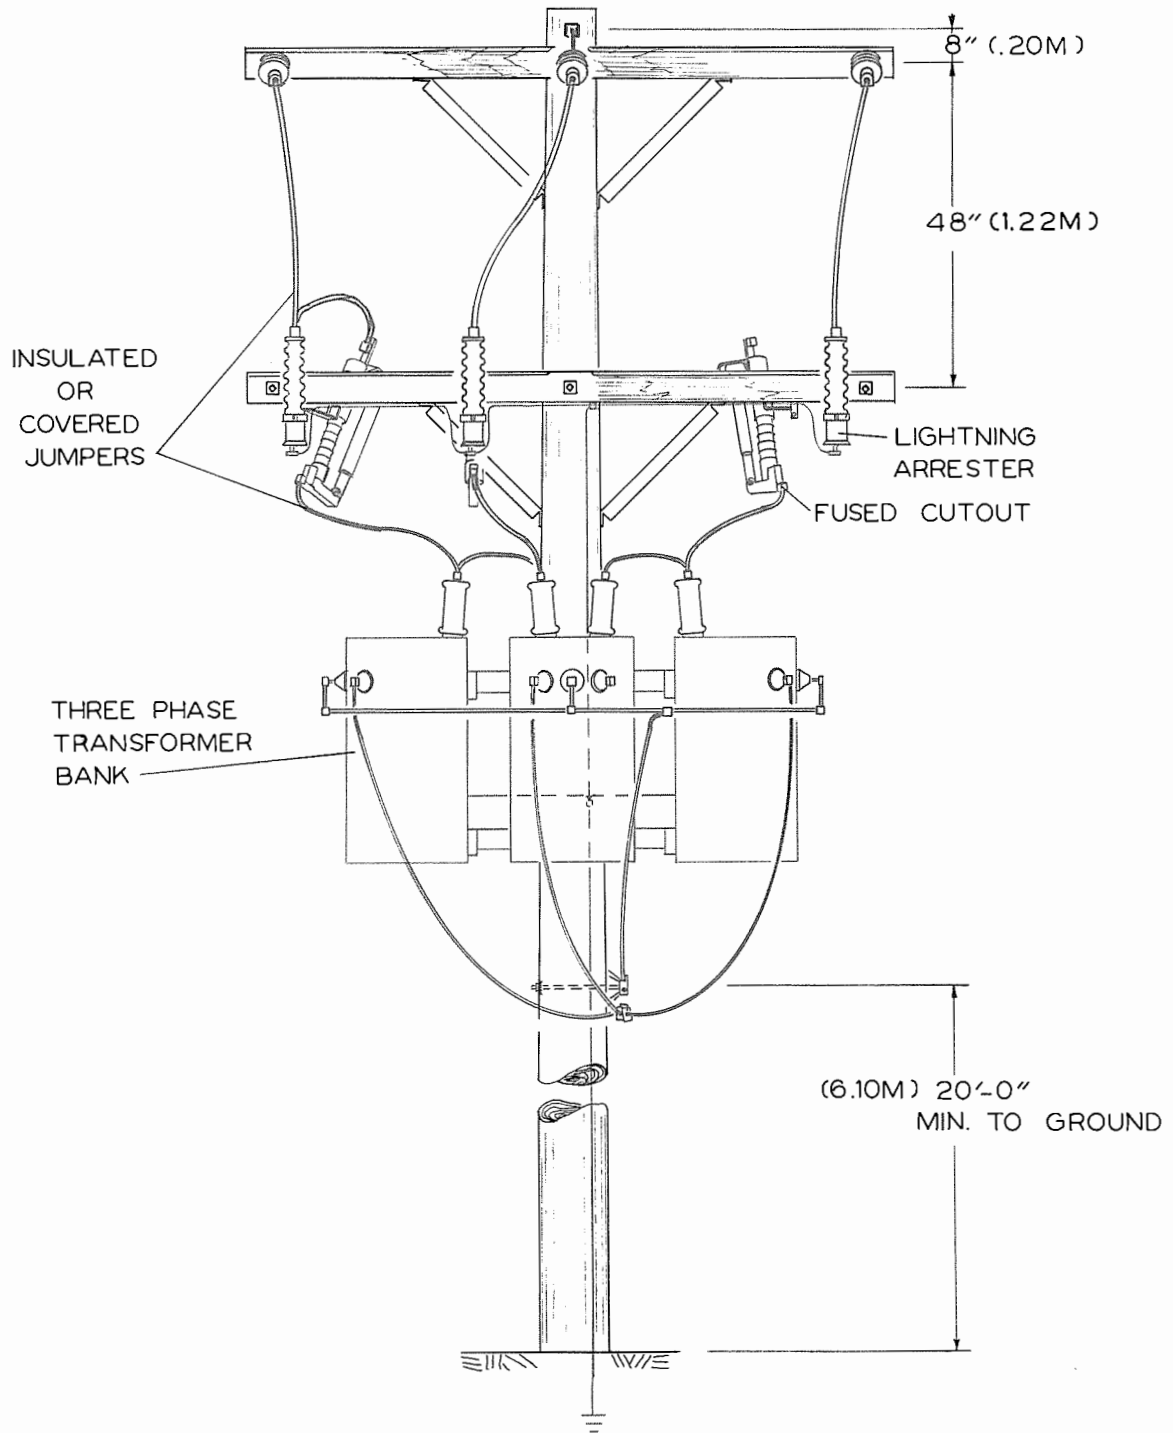
FIGURE 12  
INSTALLATION OF TRANSFORMER EQUIPMENT  
TO PROVIDE FOR RAPTOR PERCHING

As mentioned above, transformers pose especially serious problems to raptors, even the smaller species. One solution has been to install all equipment and protective devices (lightning arrestors, fused cutouts, etc.) on a second, lower crossarm which leaves the top crossarm for perching (Figure 12). This still may not be sufficient, since birds will sometimes perch atop the transformer tanks. Thus, mounting of equipment on

the second crossarm must often be done in combination with insulation of transformer risers and jumpers and with artificial perches to provide higher and safer places for the birds to sit (see below).

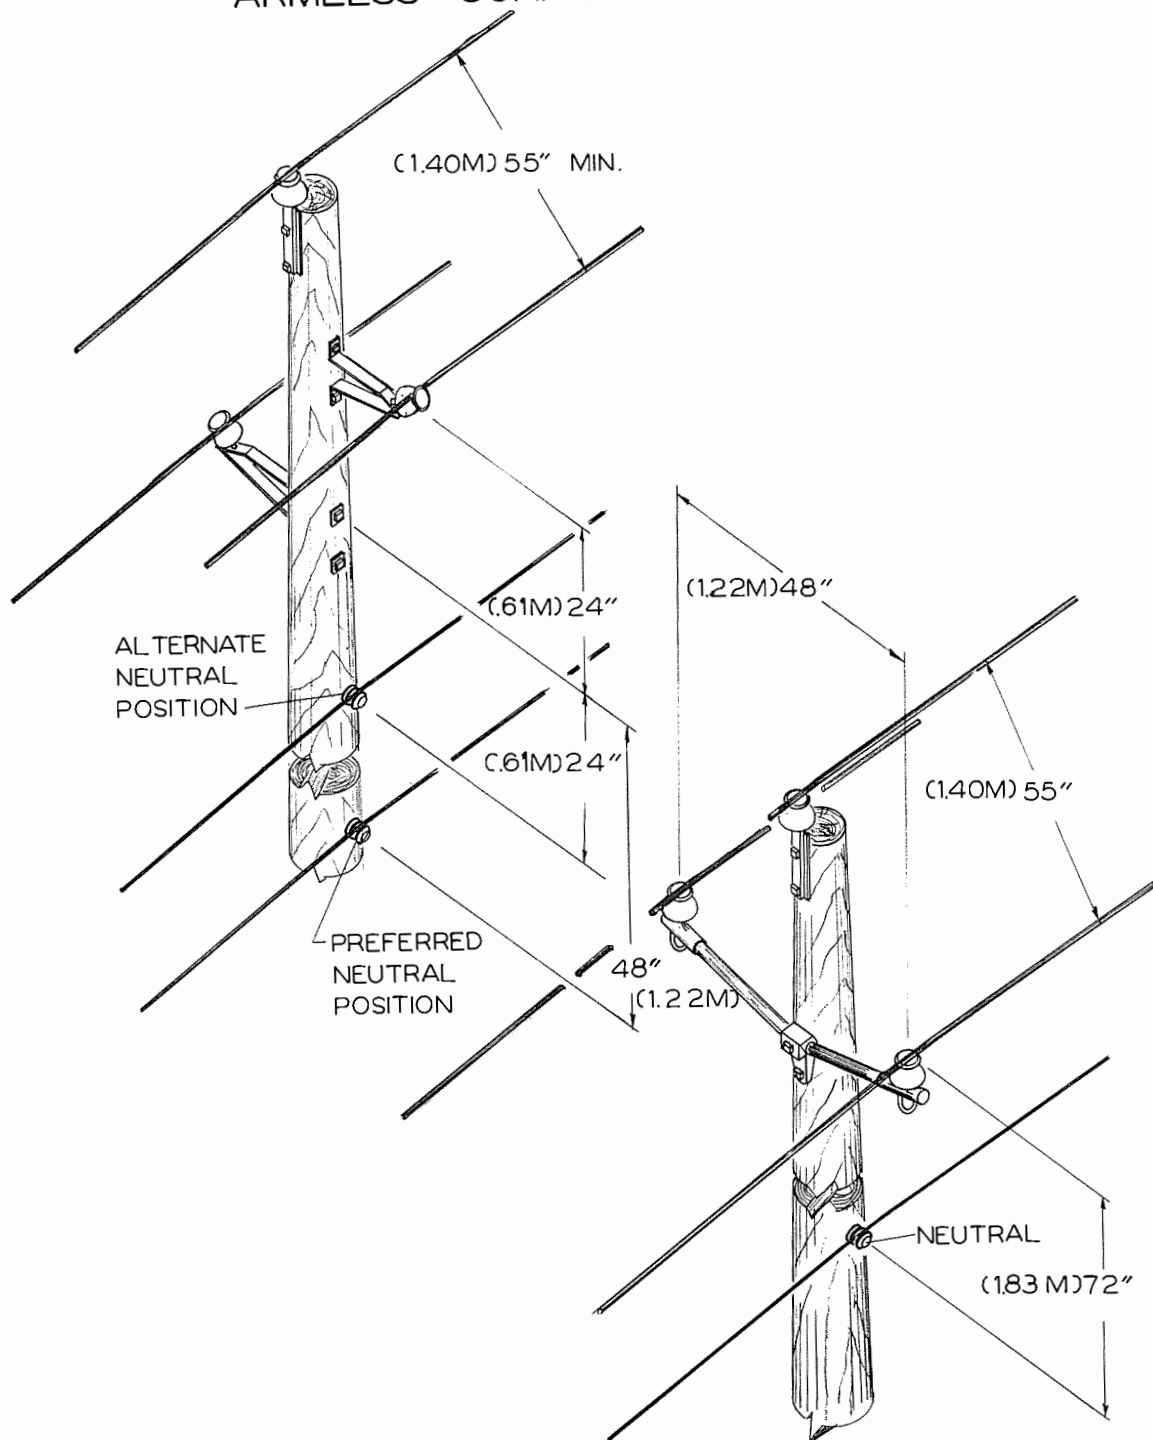
FIGURE 13  
ARMLESS CONFIGURATIONS

Armless Construction. Armless construction is an alternative to the pole/crossarm configuration and to underground placement of wires (see below). Raptor electrocution by armless configurations is minimized by limiting raptor perching primarily to the top of insulators and/or by placement of conductors alternately on one side of the pole and then the other (Figure 13). However, there have been continuing problems with some of the early armless designs depicted in Miller et al. (1975), particularly those without adequate separation between the top conductor and the next lower one. This has led to the suggestion that these conductors be at least 55 inches (140 cm) apart, which may require some lines built since 1975 to be corrected. The 55-inch (140-cm) conductor spacing for armless construction is less than the 60 inches (152 cm) suggested for pole/crossarm configurations because of the more limited mobility of eagles perched on the insulators of armless configurations.

Armless configurations (Figure 13) and underground placement of wires present special problems involving reliability and/or cost that in some circumstances decrease their attractiveness to the industry. However, new analyses of armless configurations have increased their usefulness in heavy eagle use areas.

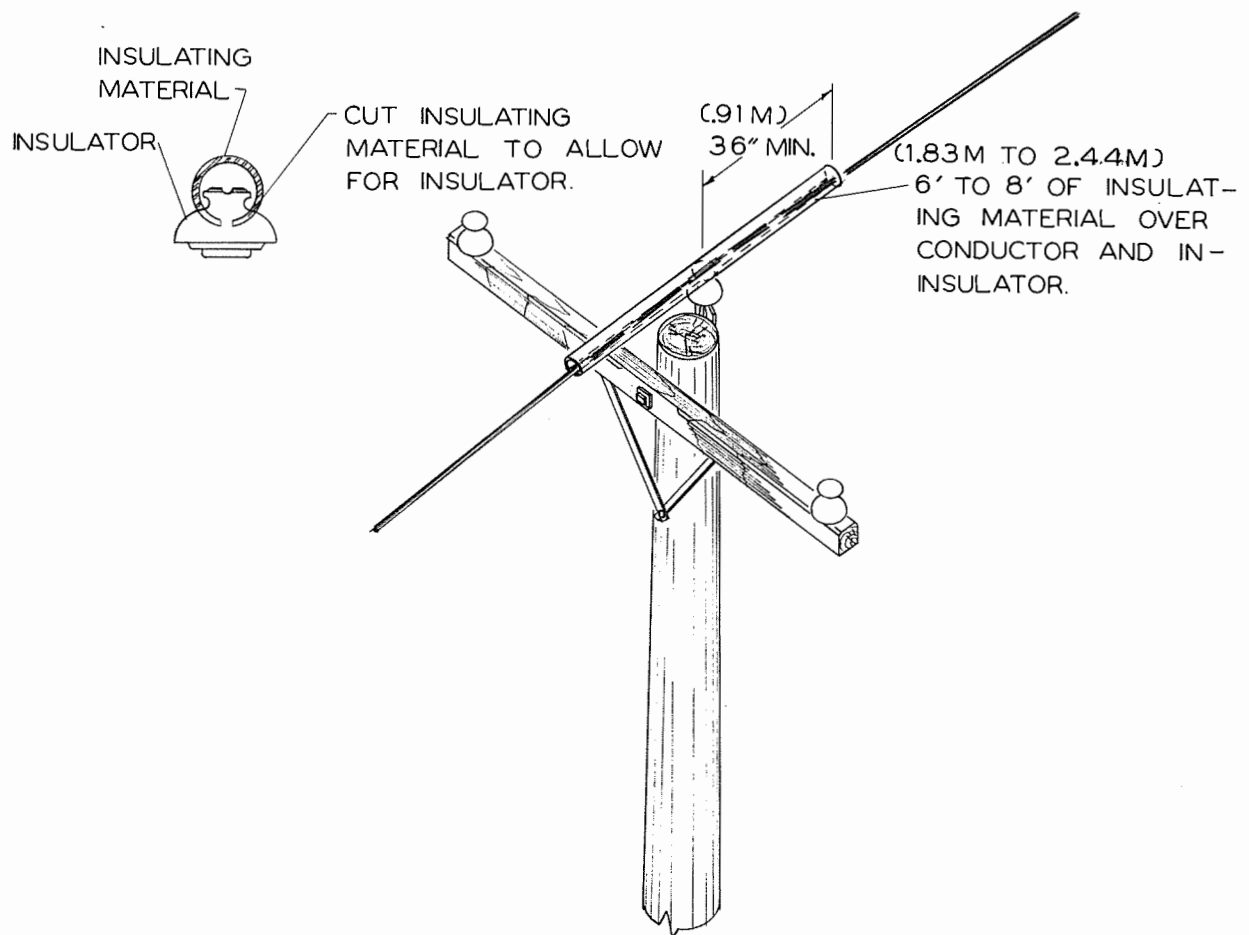
FIGURE 14  
CONDUCTOR INSULATION ALTERNATIVE

Insulation. Where adequate separation of conductors and potential conductors cannot be attained, insulation of wires and other metal equipment may be the only solution short of redesigning and extensively modifying the line. Where the center phase of a three-phase system cannot be raised and the crossarm cannot be lowered, an alternative is to install conductor insulation extending a minimum of 3 feet (0.9 m) on either side

of the pole-top insulator (Figure 14). This assembly (commonly PVC tubing) can be installed with a hot stick in a few minutes per pole, provided access is readily available to the poles. When using this type of system, wooden crossarm braces should also be employed, or, if metal braces are present, the grounding of the braces should be gapped as discussed previously.

Where adequate separation of conductors and potential conductors cannot be attained, insulation of wires and other metal equipment may be the only solution short of redesigning and extensively modifying the line. On three-phase problem configurations center conductor insulation should extend a minimum of 3 feet (0.9 m) on either side of the pole-top insulator (Figure 14).

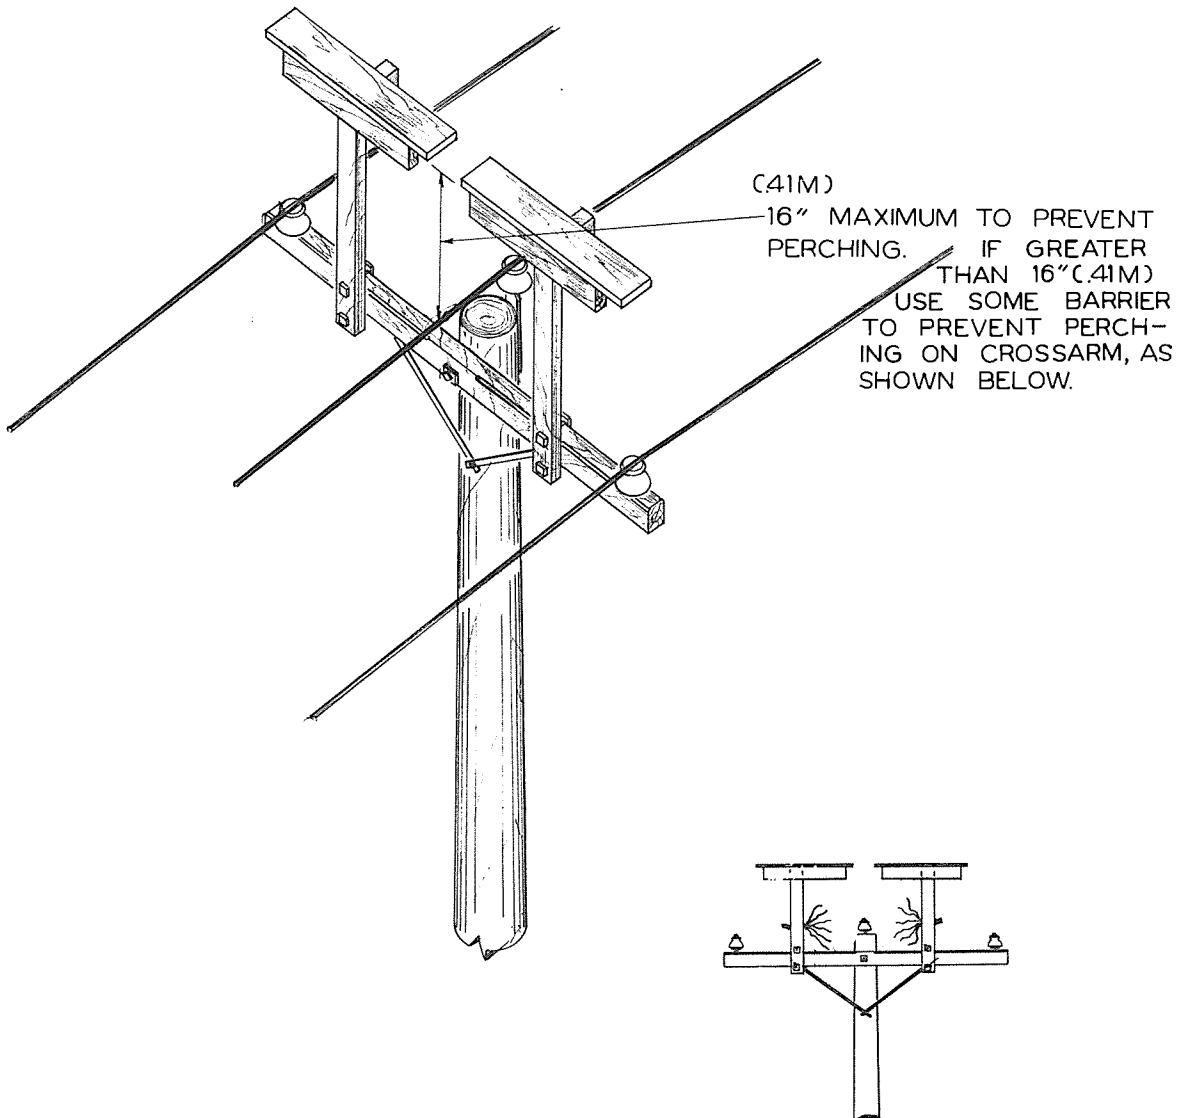
FIGURE 15  
**ELEVATED PERCH CONSTRUCTION**

Management of Eagle Perching. Two simple and economical methods of making existing problem lines safe for eagles involve encouraging eagles and other birds to perch on less dangerous parts of power line support structures. One method is to install perches, usually of 2-inch by 4-inch (5.1-cm by 10.2-cm) wooden construction, a safe distance above any energized wire or object (Miller et al. 1975) (Figure 15). This solution is not new, however, since in 1946 the Pacific Gas and Electric Company solved a severe outage problem in the Sierra Mountains by installing 2-inch (5.1-cm) wooden dowel perches on top of each of the towers in the problem area (Dickinson 1957, Benton and Dickinson 1966). The perches were high enough to allow the eagles to clear the wires on take-off.

One other factor to consider when erecting raptor perches is the orientation of the perch relative to the crossarm and to the prevailing wind. If a perch runs perpendicular to the crossarm, access is still provided to the crossarm. Perches must run parallel to the crossarm to prevent birds from getting under them. Perches should also be placed perpendicular to the prevailing wind (Benson 1981), though this may not be possible without changing the orientation of the crossarm or the entire pole. Such a change in orientation would simply be infeasible in most situations. When in doubt, the perch should be oriented parallel to the existing crossarm (Figure 15).

Two simple and economical methods of making existing problem lines safe for eagles involve encouraging eagles and other birds to perch on less dangerous parts of power line support structures. One method is to install wooden perches 14 to 16 inches (46 to 51 cm) above any energized wire or object so that raptors can sit out of danger (Figure 15). The second technique is to encourage eagles to perch in non-lethal positions on power line structures by placing perch guards (Figure 16) in dangerous

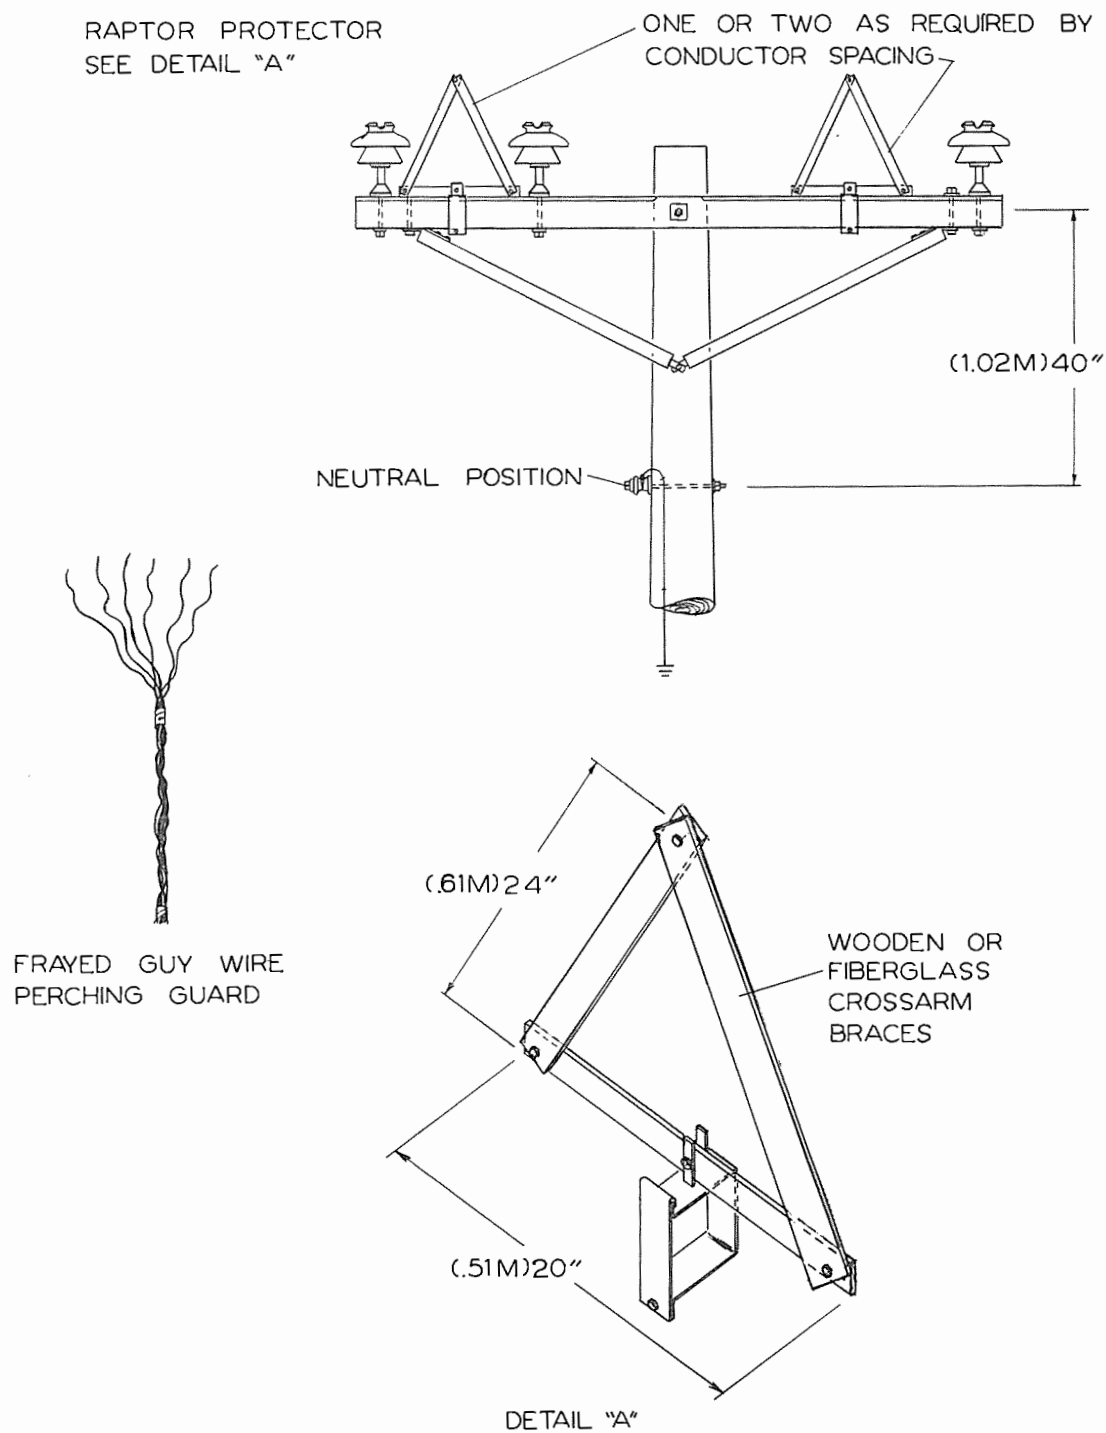
FIGURE 16  
PERCH GUARDS

Another perch guard design consisted of short pieces of large diameter standard wire with one end mounted on a base plate and the other end unraveled so that many stiff wire strands stuck out like a porcupine (Benton and Dickinson 1966, Lee 1980) (Figure 16). Nelson (1980c) tested similar devices in his "dummy pole" experiments and found them to be extremely effective.

More recently, attention has turned to an inverted "V" perch guard configuration which has been tested by Nelson (1979b, 1980c) and is currently being field tested in several forms: wood, fiberglass, and PVC rod. Specifications for the wooden and fiberglass versions are shown in Figure 16. Larger "V's" or more than one "V" may be effective for wider

perching areas on higher voltage lines, though at some point the problem disappears because of adequate phase separation. The inverted "V" perch guard has been endorsed by several power companies as an economical and effective means of protecting birds of prey (Solt 1980), particularly on structures where two conductors are carried on one side of the crossarm (Nelson 1979b, 1980c; Benson 1981). The materials are relatively inexpensive, and the units can be installed while the line is energized.

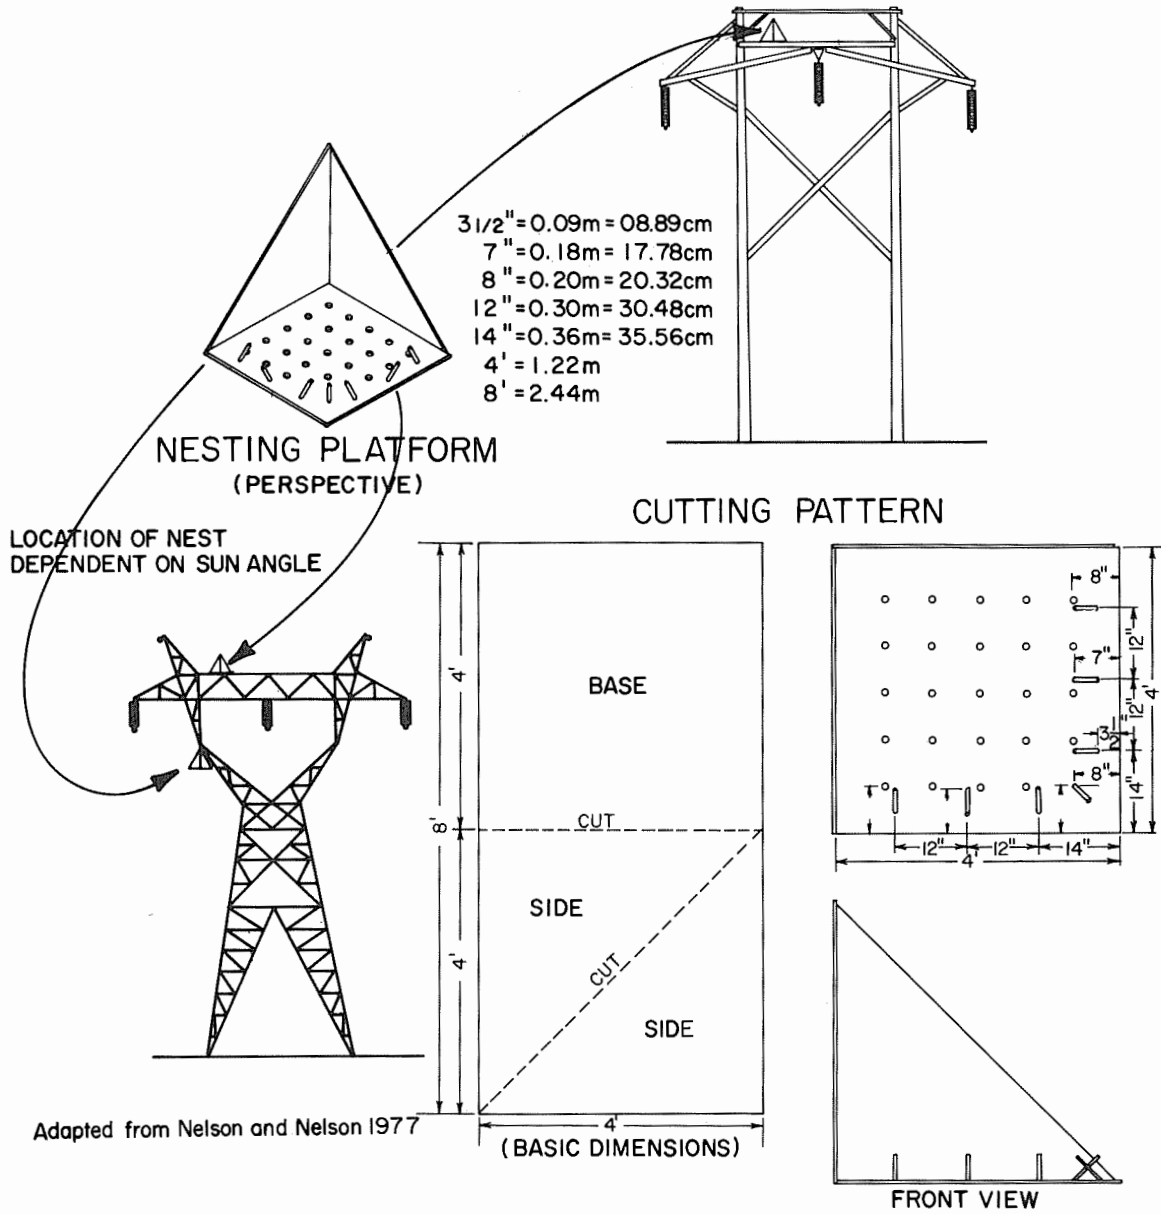
FIGURE 17

# EAGLE NESTING PLATFORMS

An artificial nest structure design by Morlan W. Nelson (Figure 17) is of particular importance in that it was developed primarily for installation on power transmission towers. The design is intended to minimize construction time, use of materials, and, thus, cost per structure. Also, with features to protect nestlings from strong winds and intense sun, the structures could easily be modified into release stations for raptors for reintroducing them into areas where they have been extirpated.
